**SITE ASSESSMENT/REMOVAL ACTION REPORT  
FOR  
601 PROPERTIES SITE  
DAYTON, MONTGOMERY COUNTY, OHIO  
TDD: S05-9608-007  
PAN: 6G0701SI**

September 27, 1996

**UNITED STATES ENVIRONMENTAL PROTECTION AGENCY  
EMERGENCY AND ENFORCEMENT RESPONSE BRANCH  
77 West Jackson Boulevard  
Chicago, Illinois 60604**

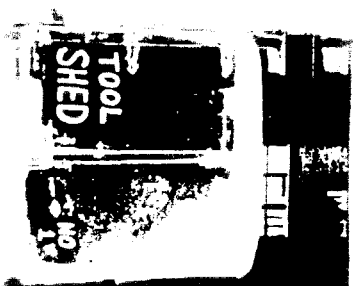
Site: 601 Properties Date: 8-28-96 Photographer: John Sherrard - E & E  
 Camera: Vivitar EZ3AFDB Big View Film: Kodak Gold 200 speed  
 Subject: Western view of abandoned trailer.

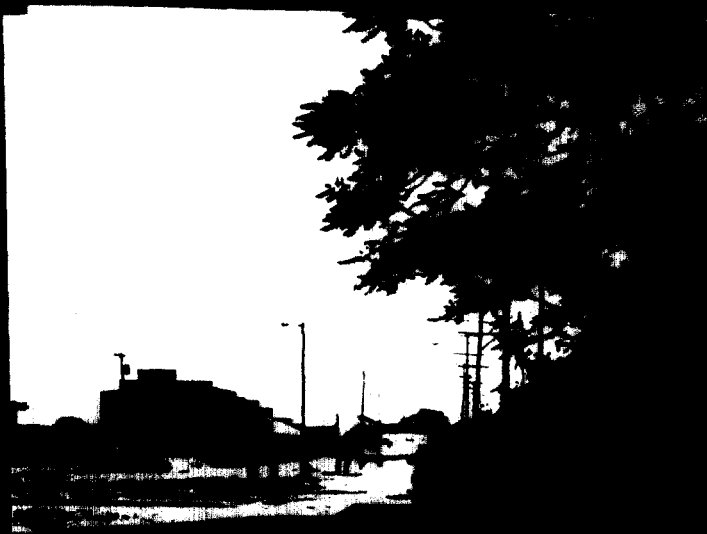
**Site:** 601 Properties **Date:** 8-28-96 **Photographer:** John Sherrard - E & E  
**Camera:** Vivitar EZ3AFDB Big View **Film:** Kodak Gold 200 speed  
**Subject:** Eastern view of alley located north of abandoned trailer.

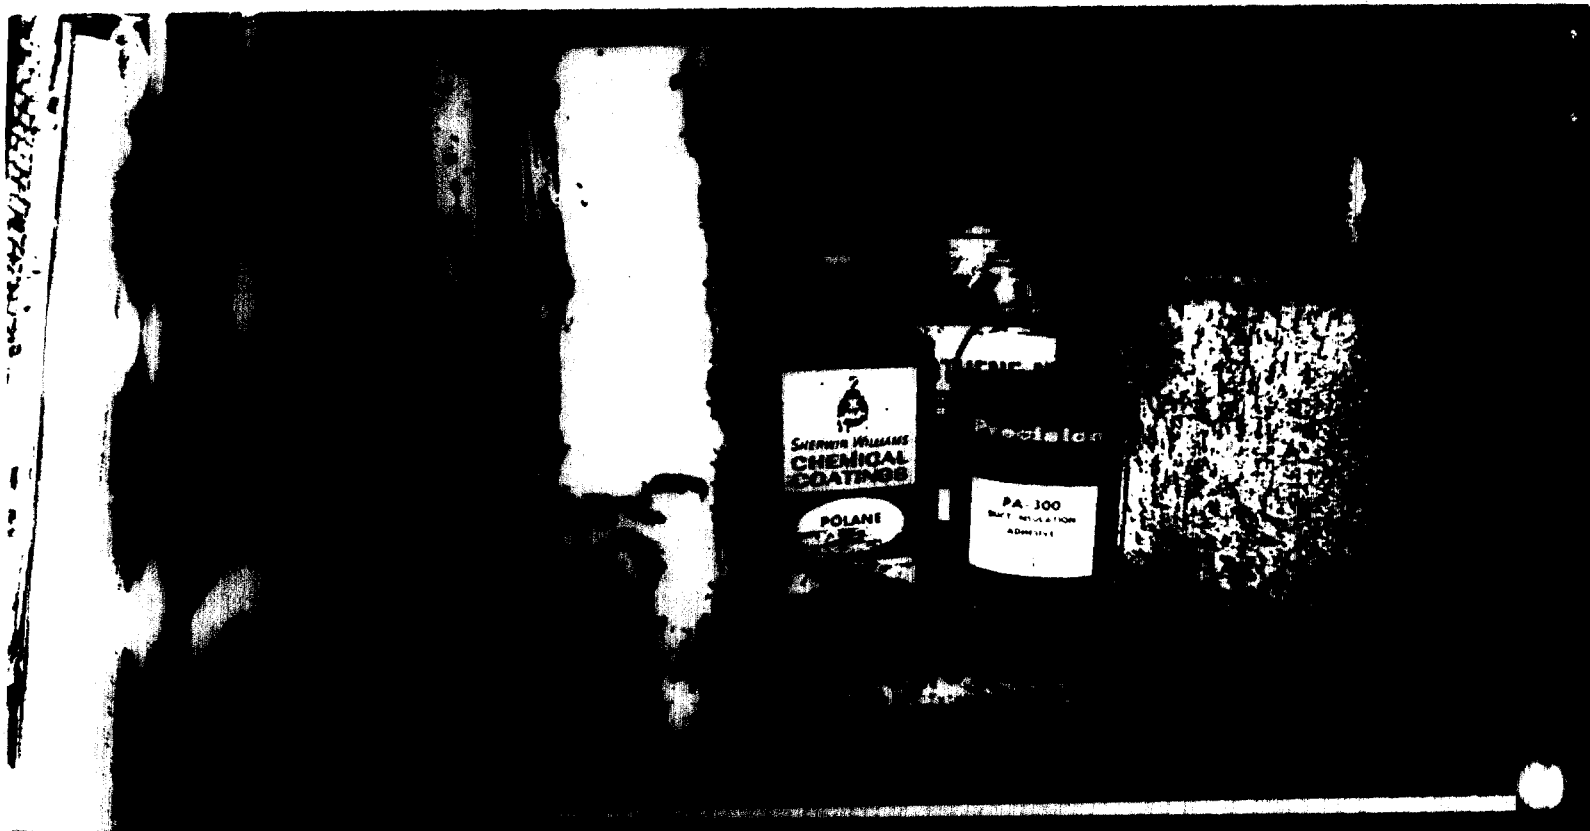
- **Threat of fire or explosion.** Through a combination of vandalism and the continued deterioration of containers, the potential exists for the uncontrolled mixture of incompatible materials such as acids, caustics, and organic solvents. When mixed, incompatible materials can react violently and generate excessive heat, which could engulf and involve other combustible or flammable materials, including the flammable solvent xylene, which was documented by chemical analyses to be present on site.

**Site:** 601 Properties **Date:** 8-28-96 **Photographer:** John Sherrard - E & E  
**Camera:** Vivitar EZ3AFDB Big View **Film:** Kodak Gold 200 speed  
**Subject:** View of containers with flammable contents.

The following removal activities are recommended in order to mitigate the threats to human health and the environment outlined in this report: stabilize leaking drums and small containers via overpacking, sample and compatibility test all drums and containers suspected of containing hazardous substances in order to determine appropriate composite categories for disposal analysis, classify all hazardous substance-containing materials into appropriate waste categories, segregate and consolidate all hazardous substance-containing materials into appropriate wastestreams, and properly containerize and ship all wastestreams off site for appropriate disposal.

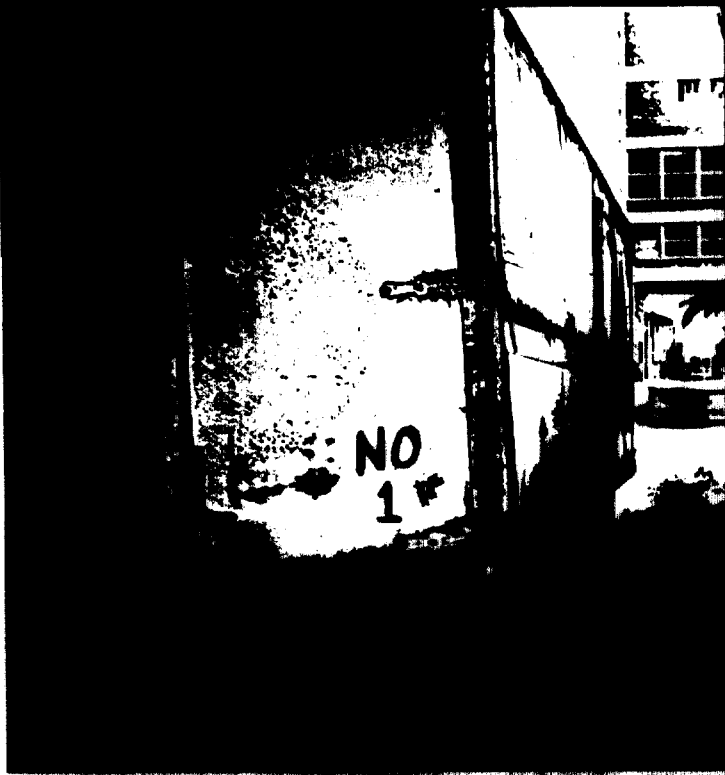
**Site:** 601 Properties **Date:** 8-28-96 **Photographer:** John Sherrard - E & E  
**Camera:** Vivitar EZ3AFDB Big View **Film:** Kodak Gold 200 speed  
**Subject:** Western view of site.
